Manhole Inspection Summary

Manhole # S55C__003MH

Insp Date: **6/23/08 1:12 PM**

Location Address: **3800 e baltimore st**

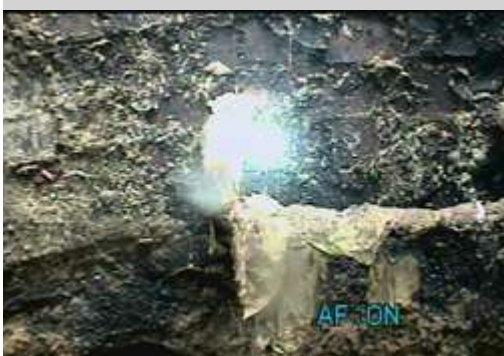
Defect 6

☒ **Evidence Of Surcharge** Depth: **3.9** (ft.) ☐ Active Surcharge Present

surcharge evidence

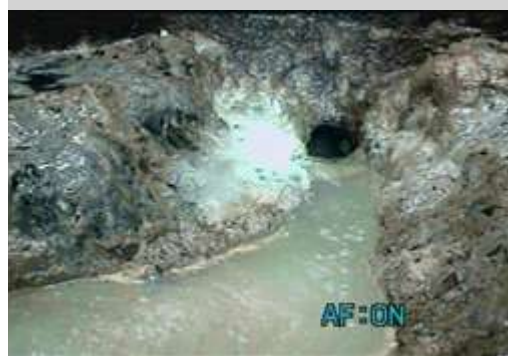
Defect 5

Condition: ☐ Sound ☐ Cracked ☐ Root Intrusion ☐ Deteriorated ☐ Leaks ☒ **Debris**

channel debris

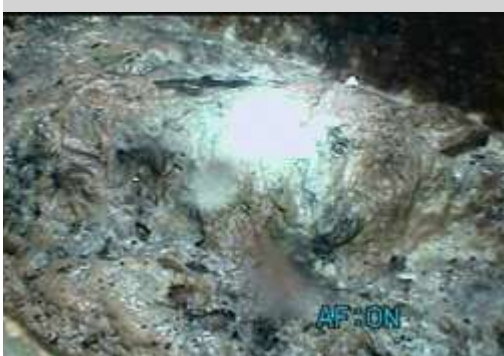
Defect 4

Condition: ☐ Sound ☐ Cracked ☐ Root Intrusion ☐ Deteriorated ☐ Leaks ☒ **Debris**

bench debris

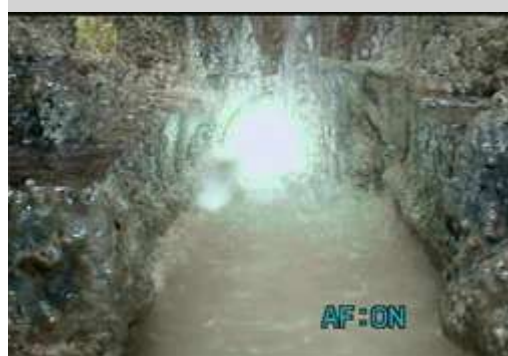
Defect 3

no pipe there at 9

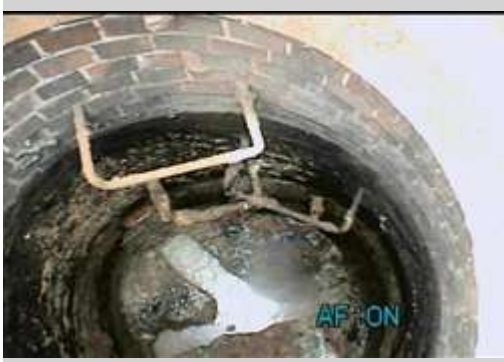
Defect 2

Infiltration: ☐ None ☐ Joint ☐ Cracks ☐ Mortar ☐ Roots ☒ **Wall**

Count: **4** Missing: **0** ☒ **Corroded**

corroded steps, barrel infiltration

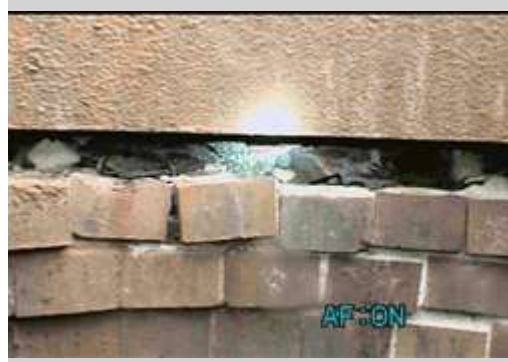
Defect 1

Condition: ☐ Sound ☐ Cracked ☐ Root Intrusion ☒ **Loose Brick** ☐ Deteriorated

Chimney loose bricks,
& loose brick in corbel

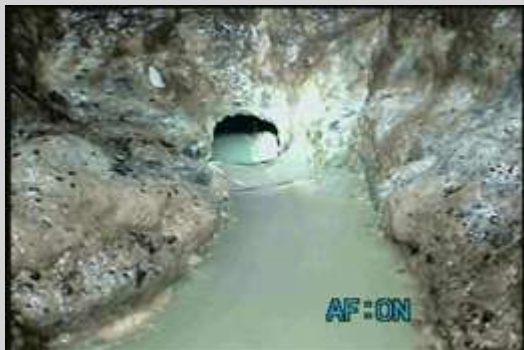
12 O'Clock Outflow

Deposits: ☐ None ☐ Mud ☐ Sludge ☒ **Debris** ☐ Grease

Silt Depth: **2** (in.) Deposits Extent: **Medium**

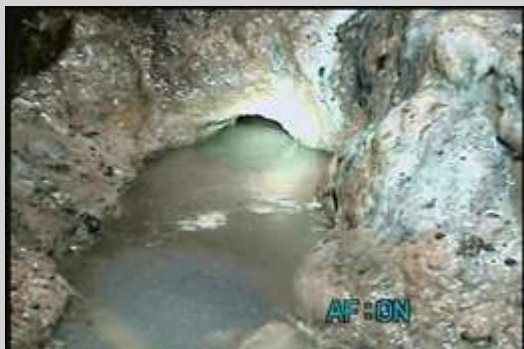
6 O'Clock Inflow

Deposits: ☐ None ☐ Mud ☐ Sludge ☒ **Debris** ☐ Grease

Silt Depth: **4** (in.) Deposits Extent: **Heavy**

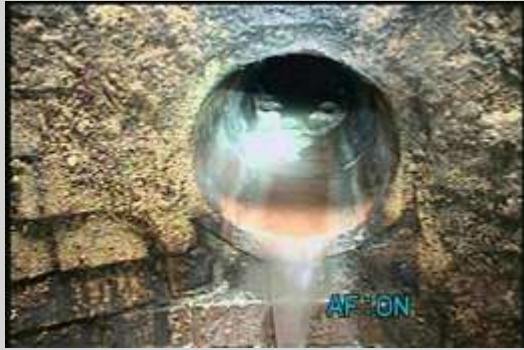
9 O'Clock Inflow

its not a drop there is no pipe below it
